AFWAL-TR-84-2048

DAMAGE CAUSED TO POLYURETHANE FOAMS BY AGING,
SIMULATED SUNLIGHT EXPOSURE, HEAT AND FIRE

Leo Parts
MONSANTO RESEARCH CORPORATION
DAYTON LABORATORY
1515 NICHOLAS RD.
DAYTON, OHIO 45407

JULY 1984

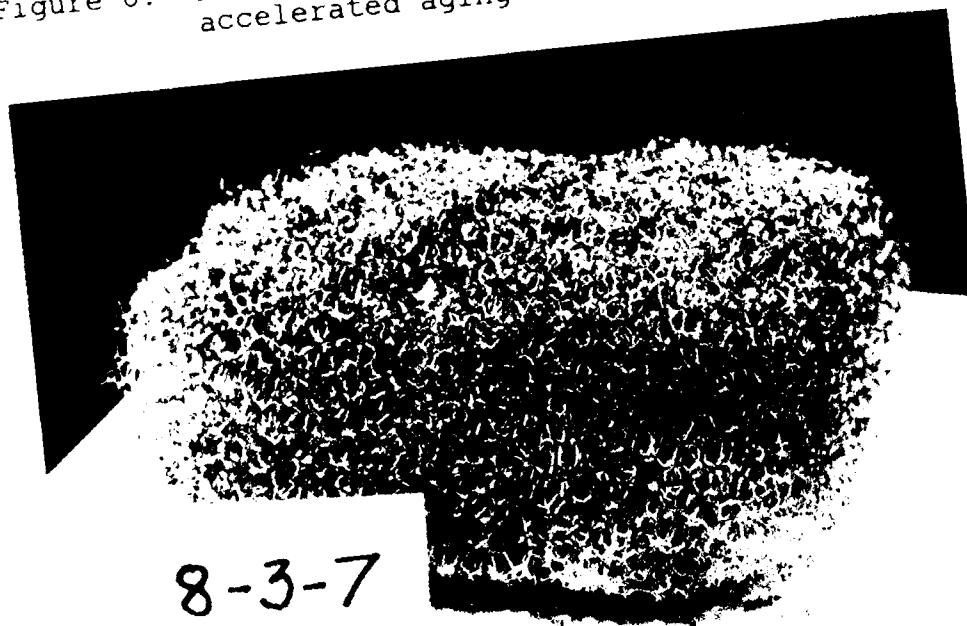
Figure 7. Yellow foam specimen, after three weeks of accelerated aging in air.

The blue foam acquires grayish appearance and discolors upon aging. The red foam becomes brownish-red, and the yellow foam becomes brown as the exposure progresses.

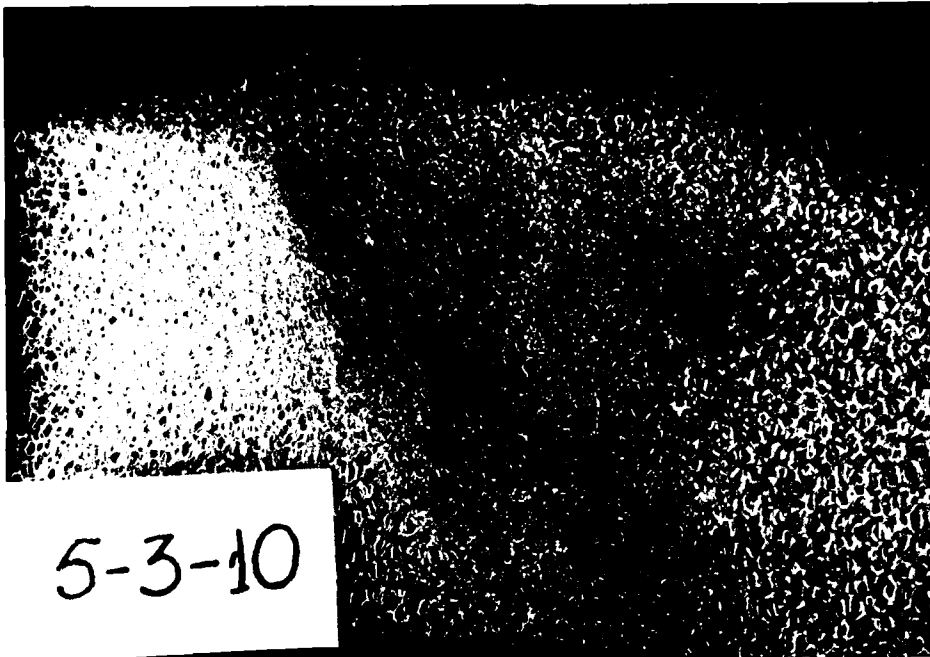
Upon closer inspection, molten and subsequently solidified droplets of polymer mass can be observed on the walls of the recession (see Figure 12).

Figure 12. Cross-sectional close-up view of red foam specimen subjected to hot air impingement.

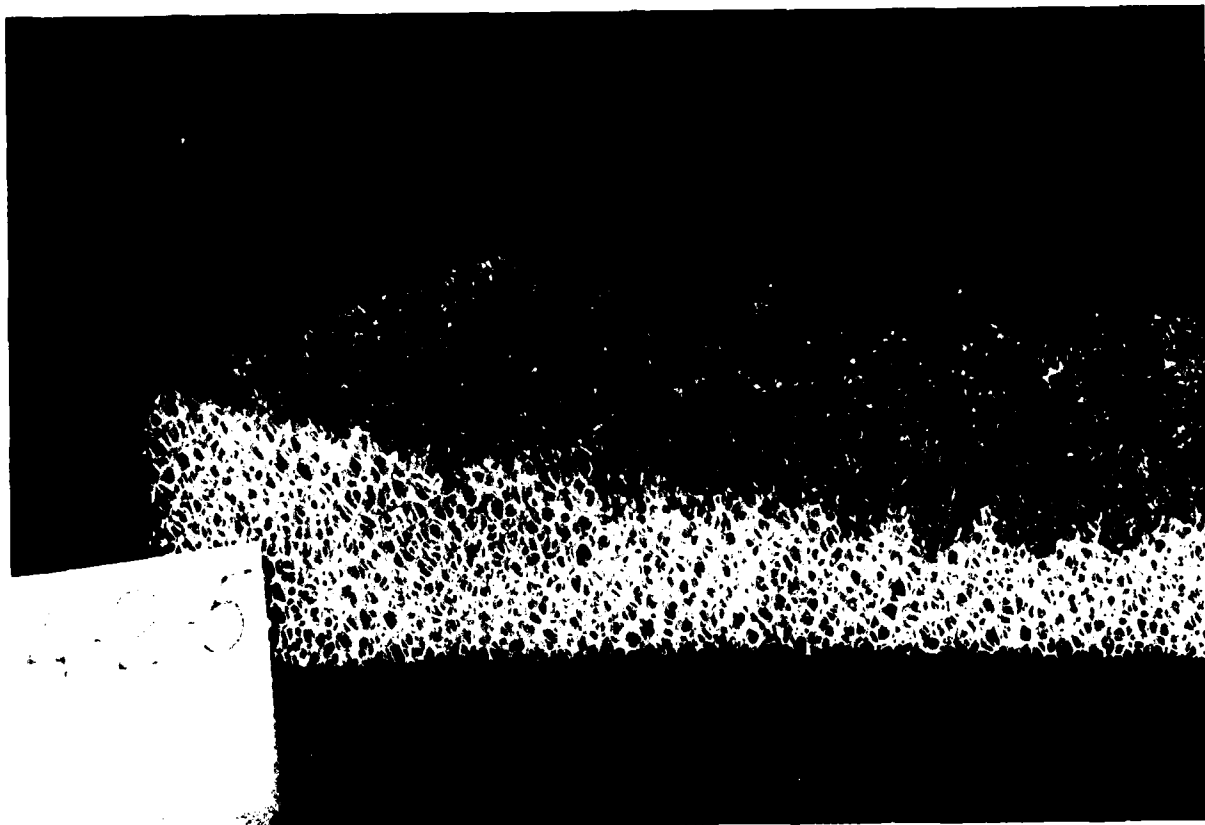
Intense flames spread very rapidly across entire blue foam specimens that had been soaked in JP-5. During the initial burning phase, the fuel was the major combustible component. Severe darkening of foam surface was observed already during the initial burning (see Figure 17). The discoloration of foam below the combustion zone was slightly more noticeable with fuel-soaked samples, than with dry specimens (compare Figures 15 and 17). More discoloration below the flame zone occurred with fuel-soaked samples during vertical burning than in the course of horizontal top surface burning (compare Figures 17 and 18).

Figure 18. Cross-sectional view of fuel-soaked blue foam specimen that had been involved in sustained burning in vertical position.

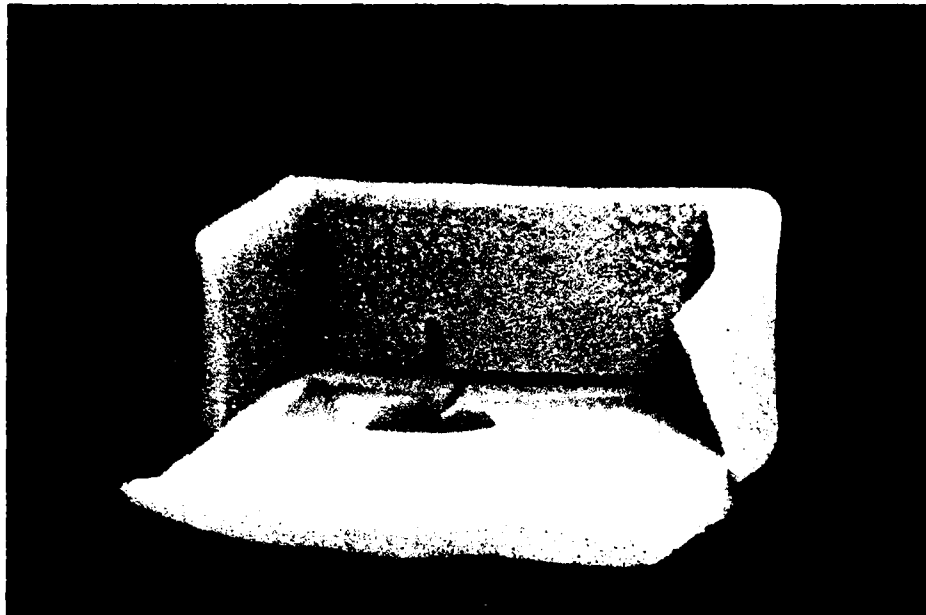
The inside surface of the depicted assembly of void filling foam (Specimen No. 4; see Figures 35 to 37) had been exposed to flash fire(s) of short duration. The surfaces of foam pieces were singed. The damage did not extend into the foam.

Figure 35. Wing tank foam, A/C 78-717
(Specimen No. 4).

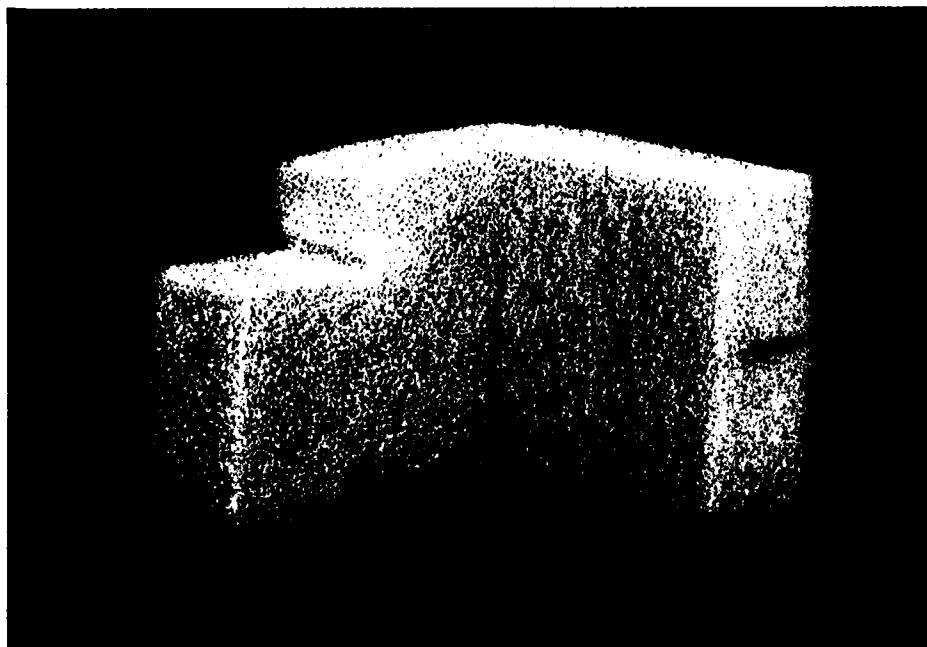
Most extensive discoloration is believed to be related to most severe exposure to the flash fire (see the upper left corner of the specimen in Figure 39). By exposing a cross-sectional area below the tan surface, it was learned that the damage did not extend deep below the surface ($\leq 1/8$ in.). Microscopic examination of the affected surface revealed degradation and darkening of polymer strands, especially at the ends formed in hot wire cutting. The shallow penetration of damage, and evidence of thermal degradation and darkening at the surface, are characteristic signs of hot wire cutting and flash or brief duration fire exposure (see Table 11).

Figure 39. Inside view of foam specimen from the wing tank of A/C 78-717.

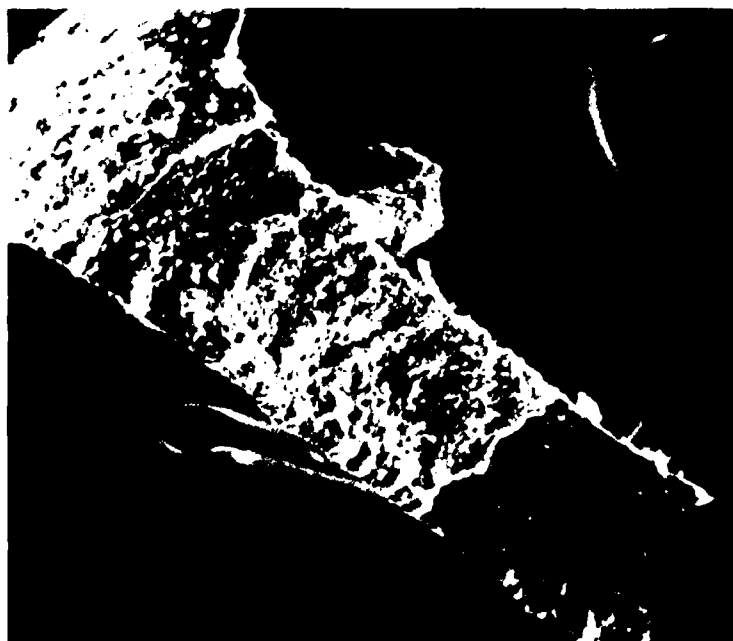
Figure 42. Scanning electron photomicrograph of deposit on vent tank foam from A/C 78-717 (100X).

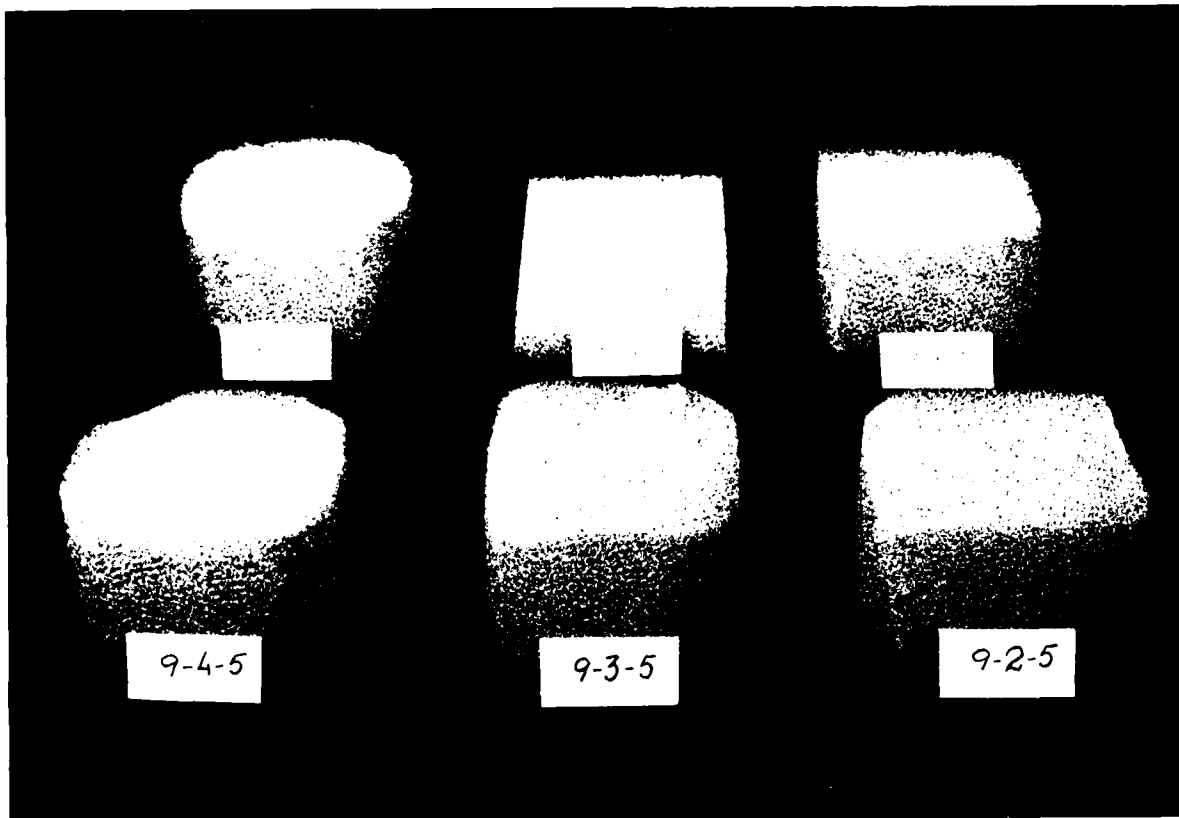
Figure A1-24. Specimens of red foam, subjected to accelerated aging in JP-5 at 200°F (93°C) for one to five weeks.

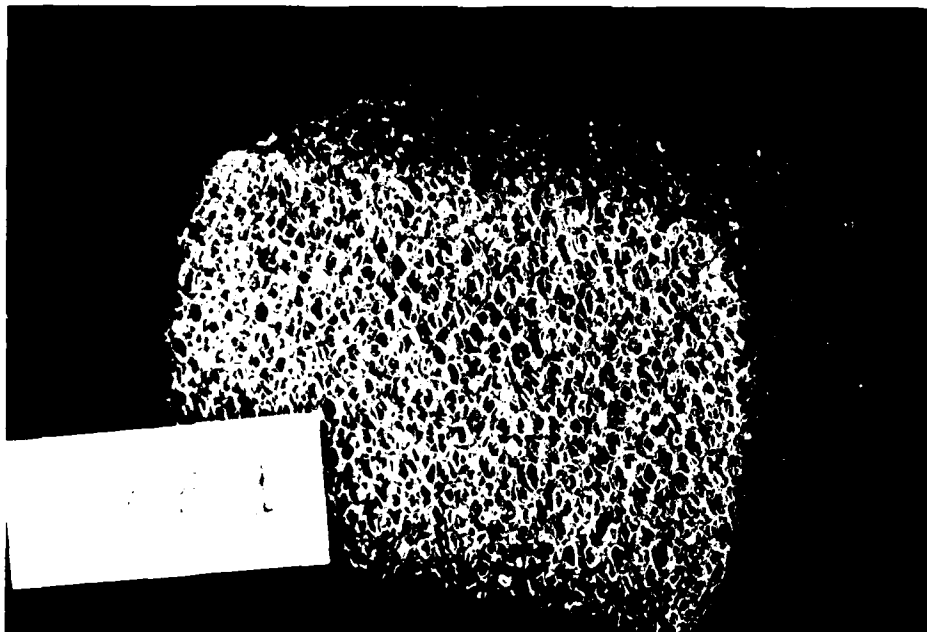
Figure A1-22. Sample 9-5-1, perspective view.

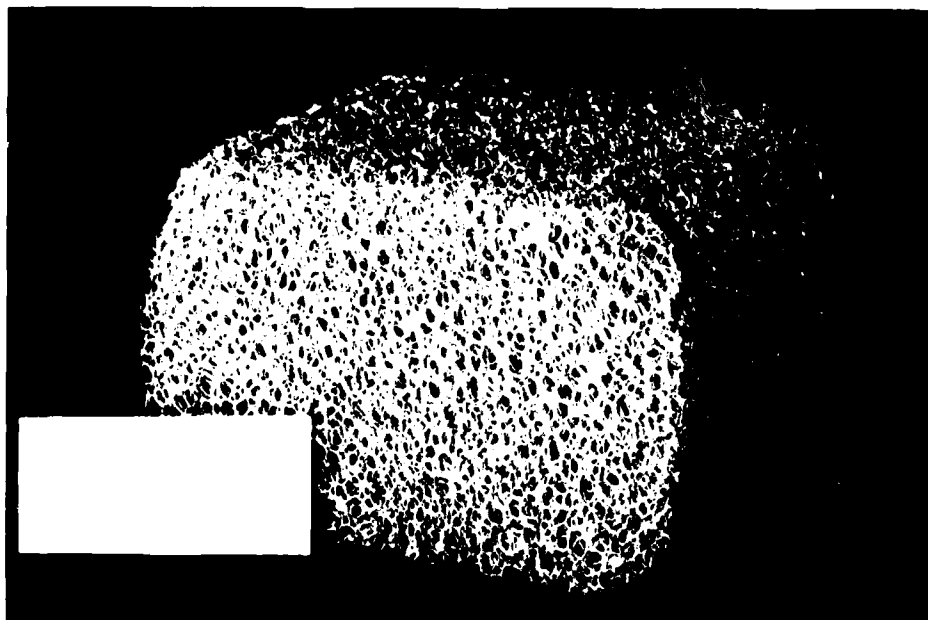
Figure A1-23. Sample 9-5-1, cross-sectional view.

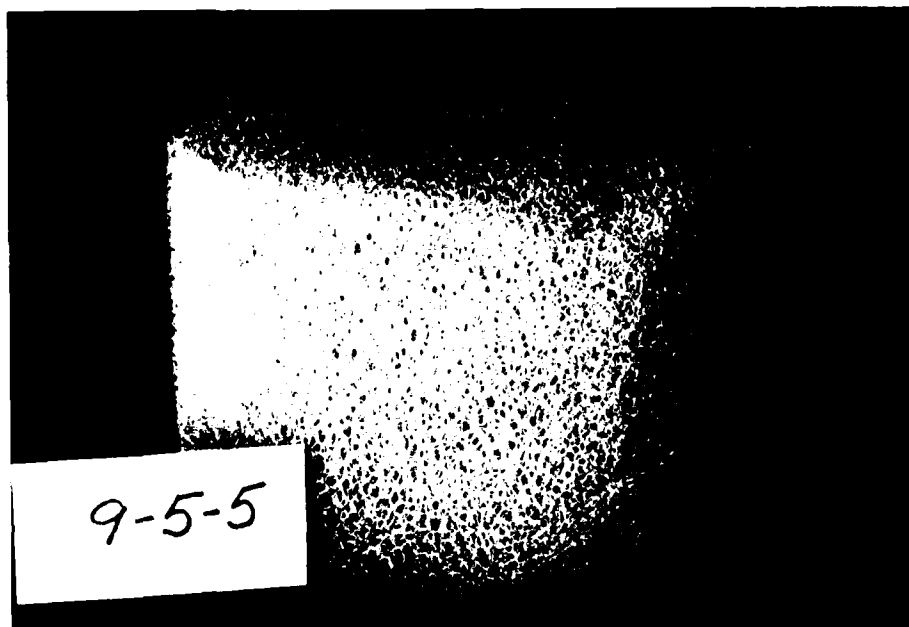
Figure A1-20. Cross-sectional view of blue, red, and yellow foam specimens, subjected to accelerated aging in JP-5 for five weeks.

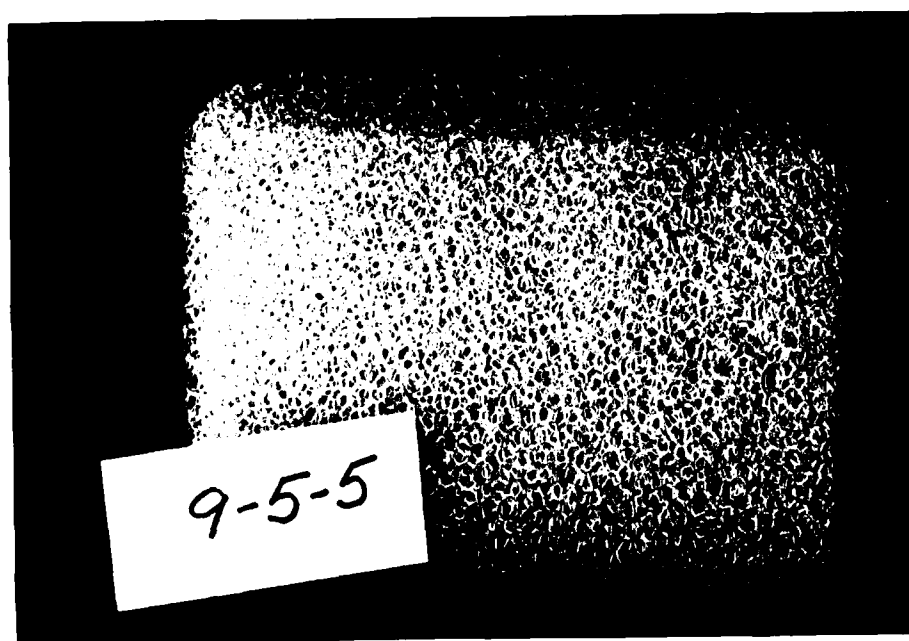
Figure A1-21. Specimens of blue foam, subjected to accelerated aging in JP-5 at 200°F (93°C) for one to five weeks.

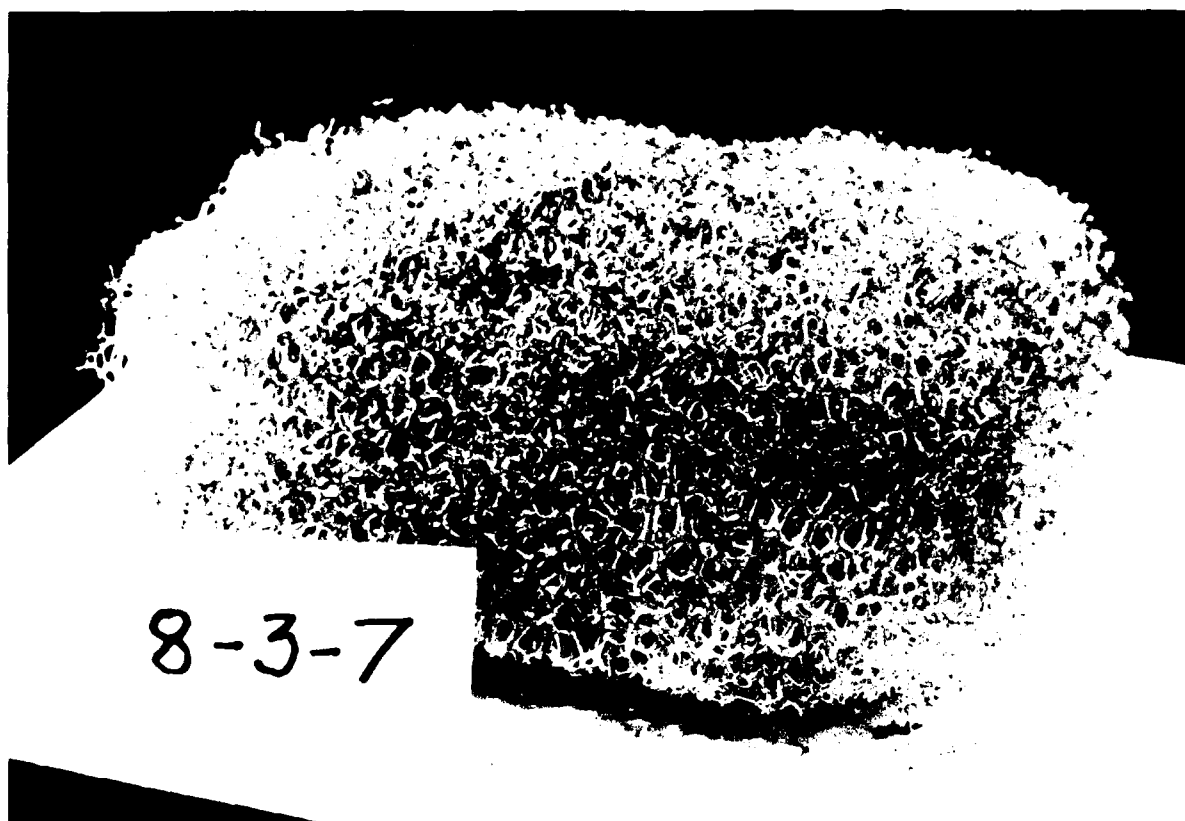
Figure A1-19. Yellow foam specimen 8-3-7, after three weeks of accelerated aging in air at 200°F (93°C).

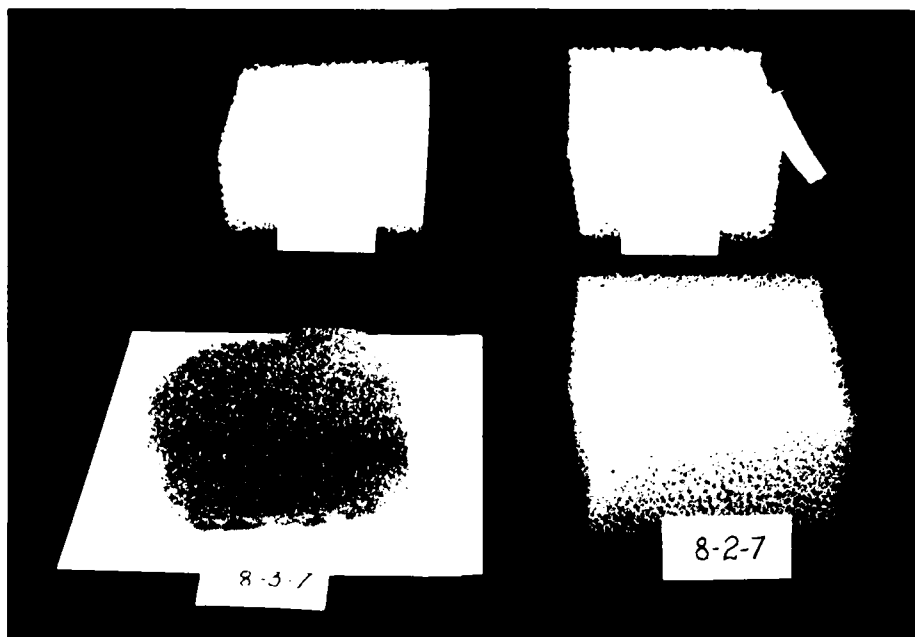
Figure A1-15. Specimens of yellow foam, subjected to accelerated aging in air at 200°F (93°C) for one to three weeks.

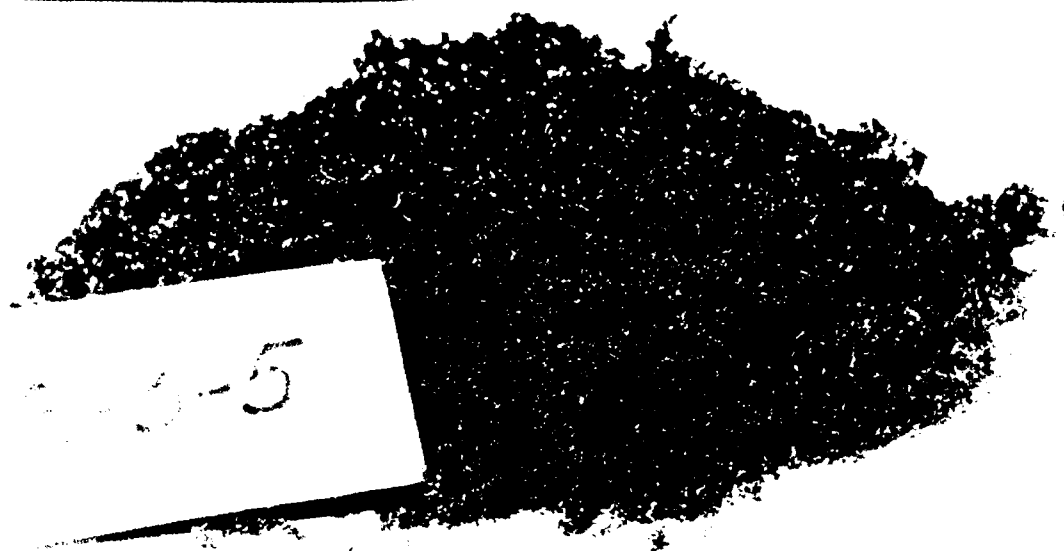
Figure A1-14. Red foam specimen 8-3-5, after three weeks of accelerated aging in air at 200°F (93°C).

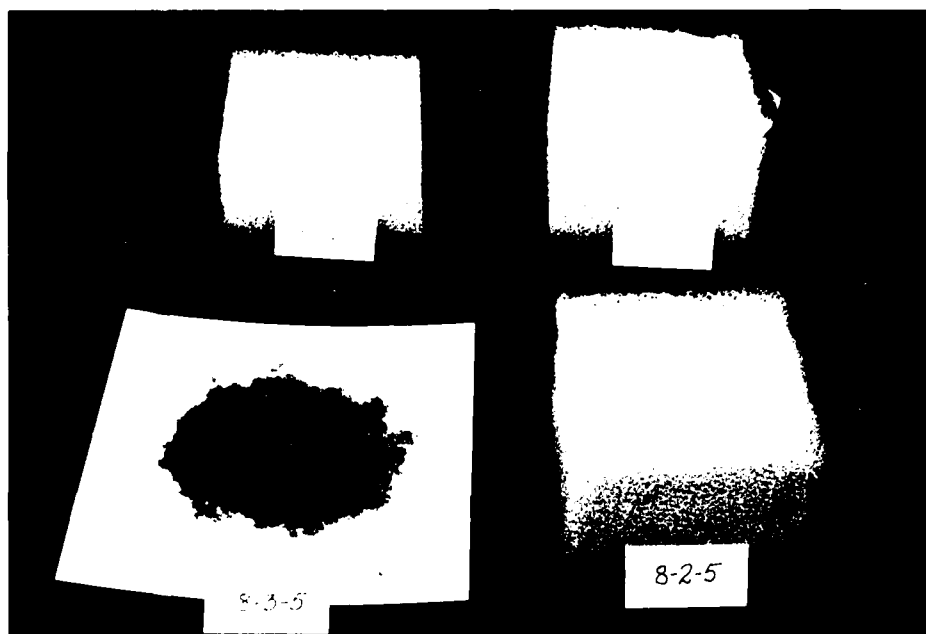
Figure A1-10. Specimens of red foam, subjected to accelerated aging in air at 200°F (93°C) for one to three weeks.

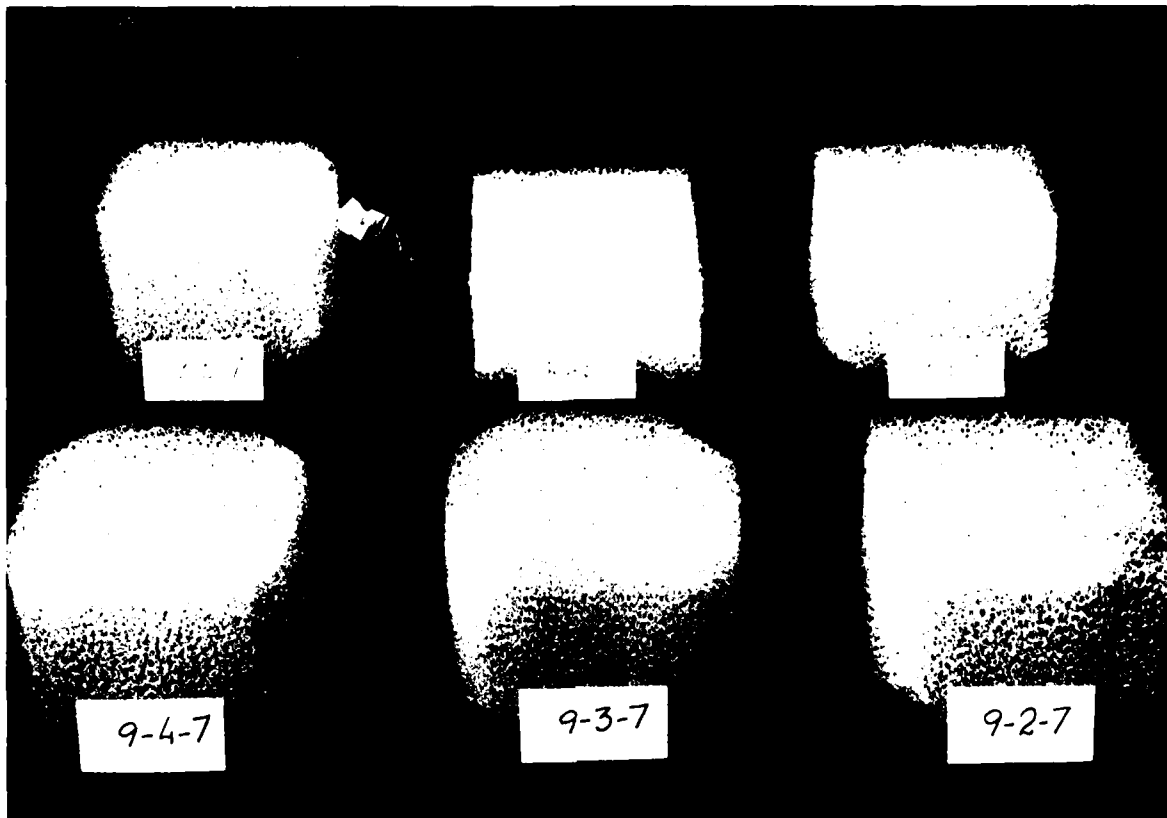
Figure A1-30. Cross-sectional view of blue, red, and yellow foam specimens, subjected to 200 hours of simulated sunlight exposure.

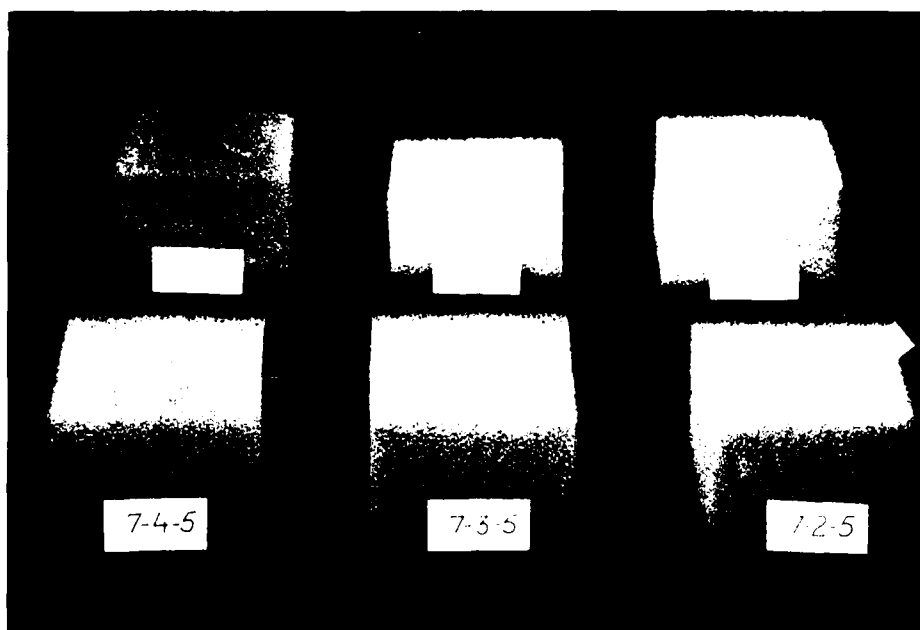
Figure A1-31. Specimens of blue foam, subjected to 40-200 hours of simulated sunlight exposure.

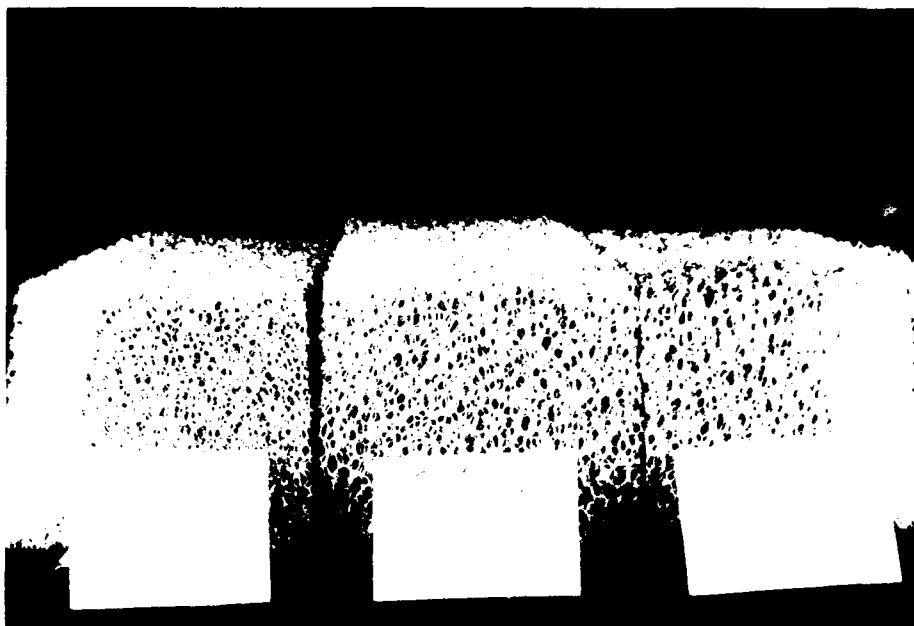
Figure A1-46. Specimens of blue foam, cut along the upper surface at 10, 5, and 2.5 ft/min, respectively.

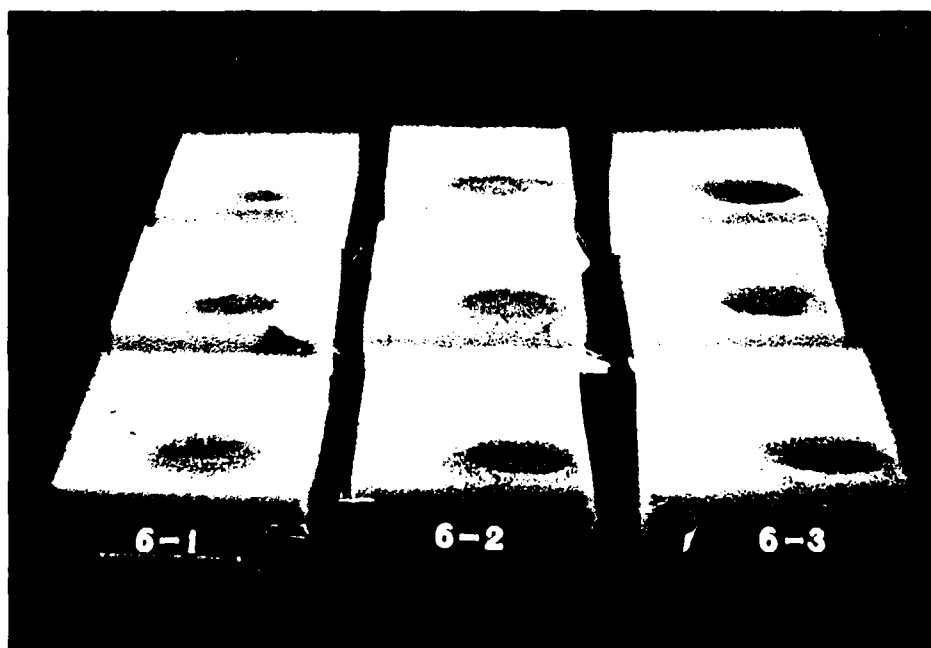
Figure A1-70. Perspective view of blue foam specimens, subjected to radiant heat exposure for 10, 20, and 30 seconds, respectively.

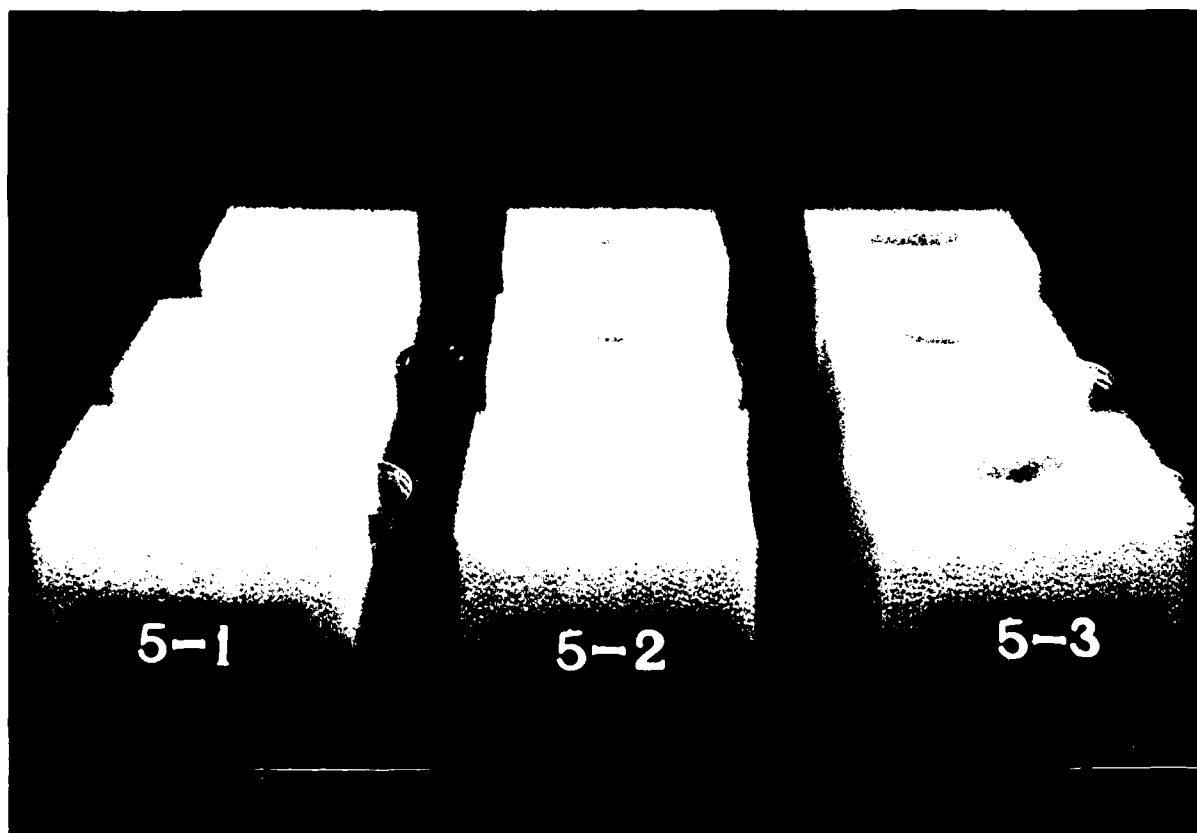
Figure A1-62. Perspective view of red foam specimens, subjected to hot air impingement for ~2, ~3.5, and ~5 seconds, respectively.

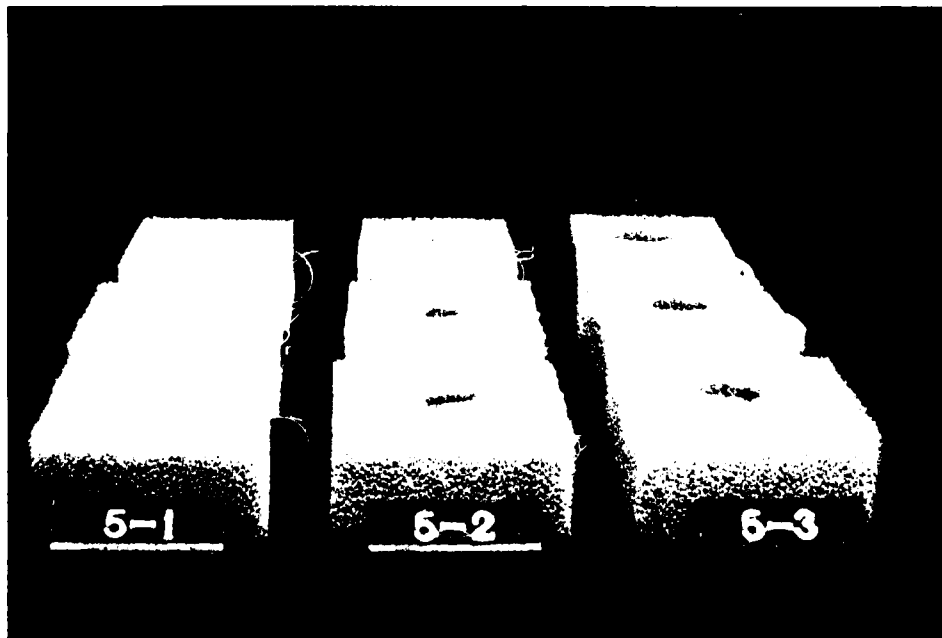
Figure A1-53. Perspective view of blue foam specimens, subjected to hot air impingement for ~2, ~3.5, and ~5 seconds, respectively.

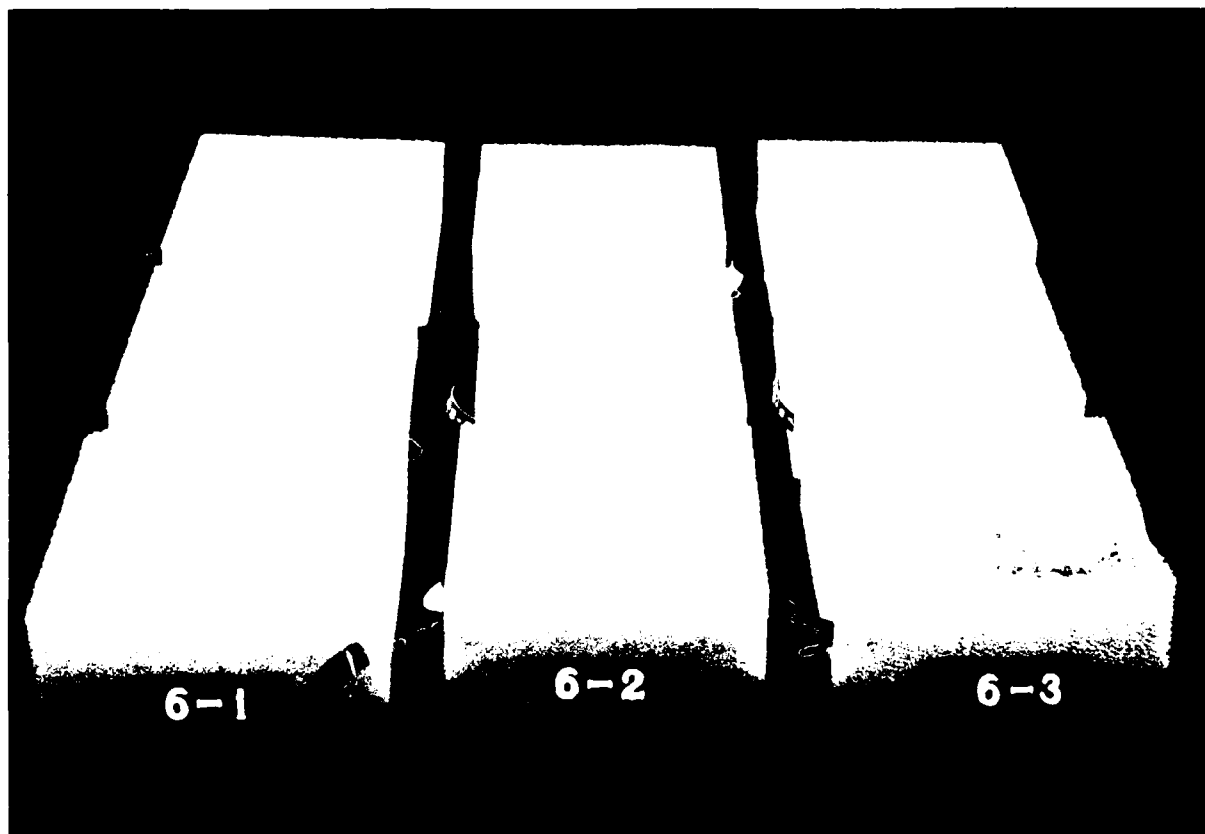
Figure A1-79. Perspective view of red foam specimens, subjected to radiant heat exposure for 10, 20, and 30 seconds, respectively.

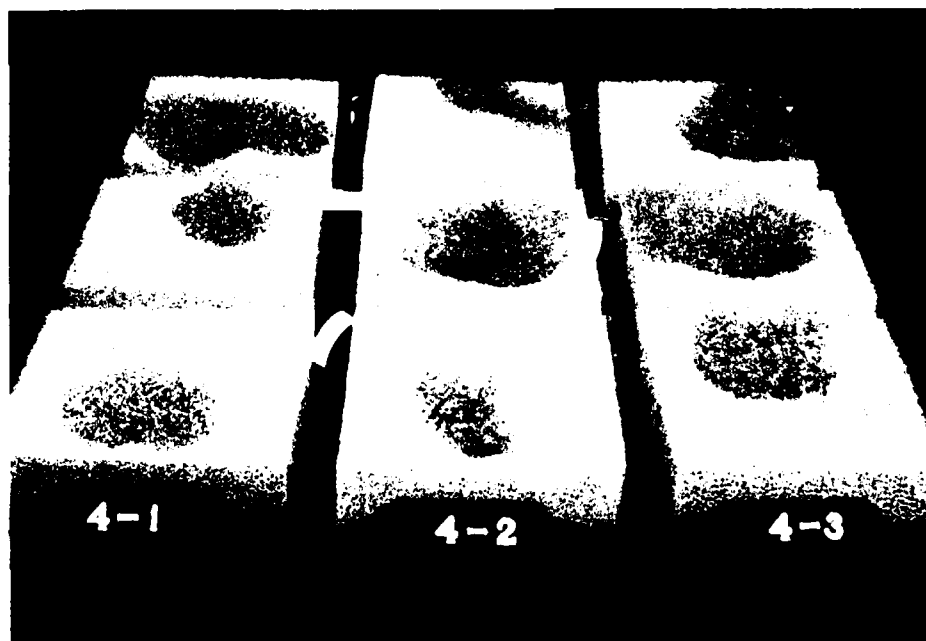
Figure A1-115. Perspective view of blue foam specimens, subjected to sustained burning. Samples ignited by flame from top while in horizontal position, and from bottom while in vertical and horizontal positions, respectively.

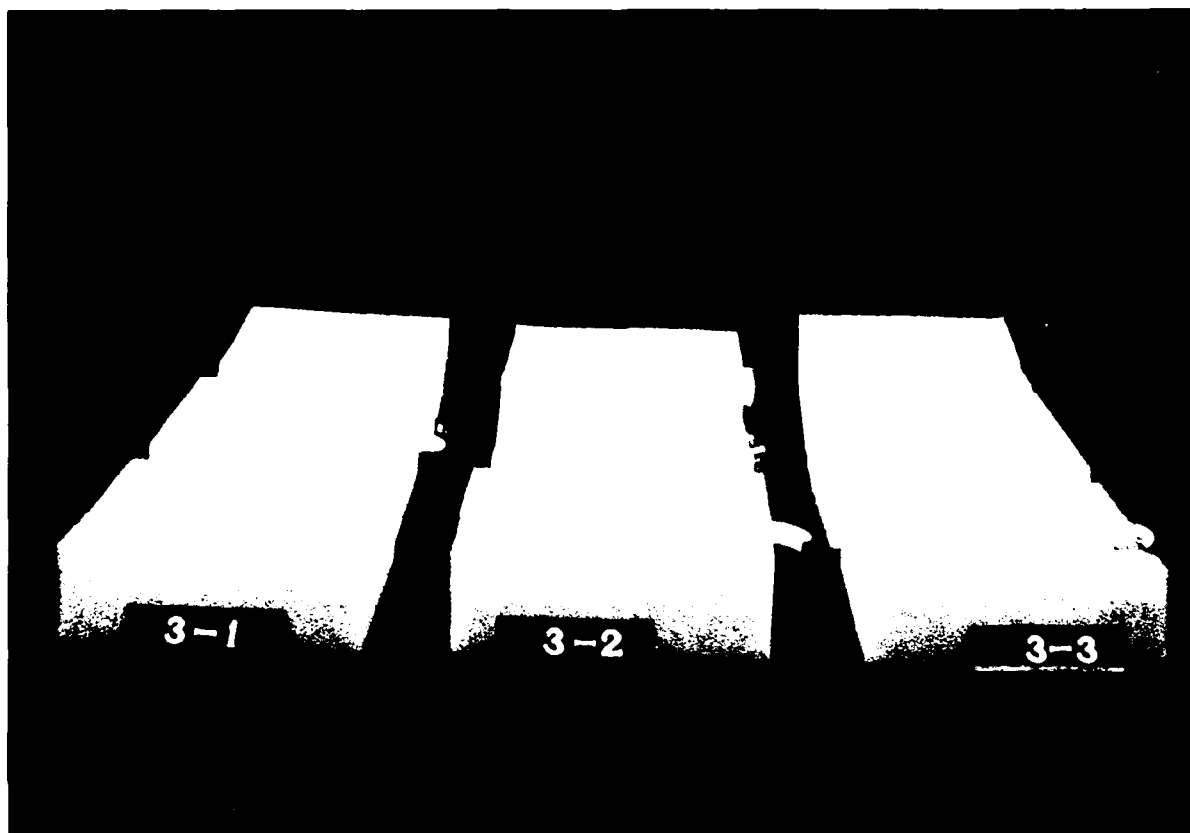
Figure A1-107. Perspective view of yellow foam specimens, subjected to brief flame impingement from top while in horizontal position, and from bottom while in vertical and horizontal positions, respectively.

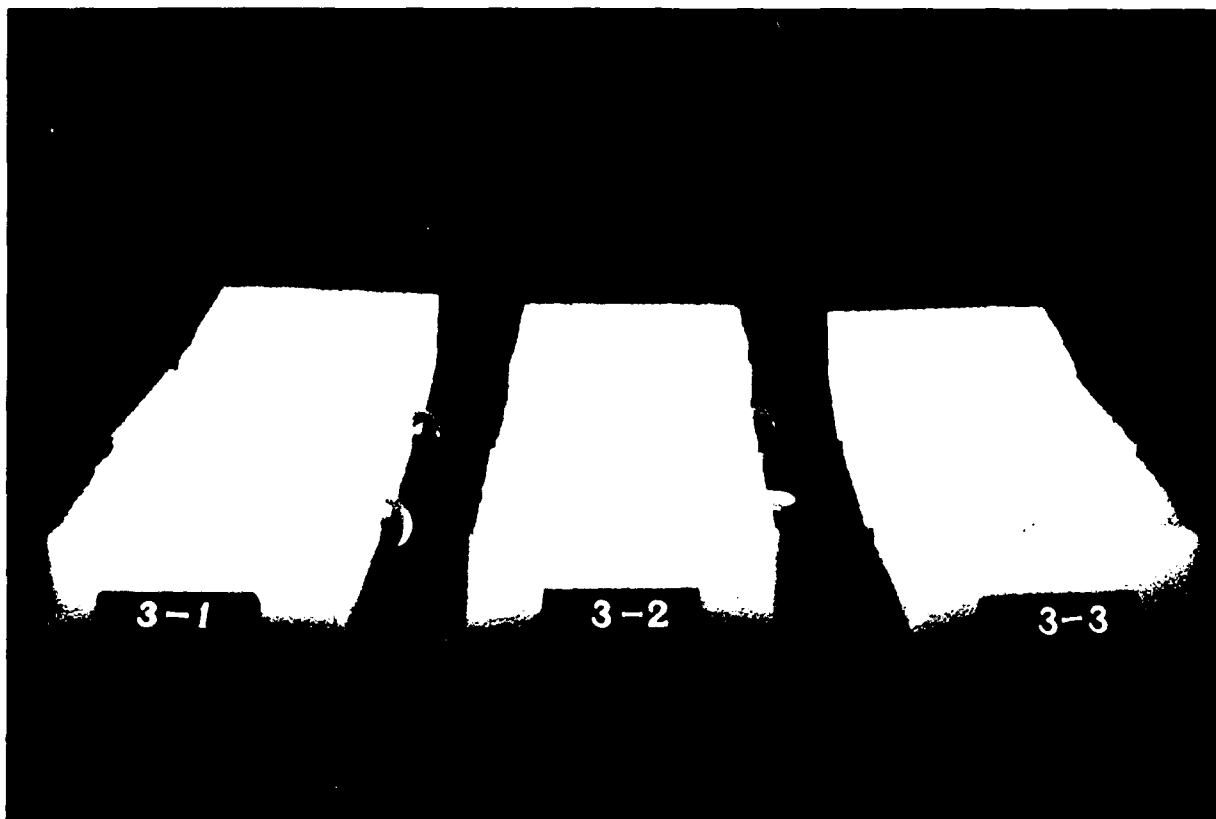
Figure A1-100. Perspective view of red foam specimens, subjected to brief flame impingement from top while in horizontal position, and from bottom while in vertical and horizontal positions, respectively.

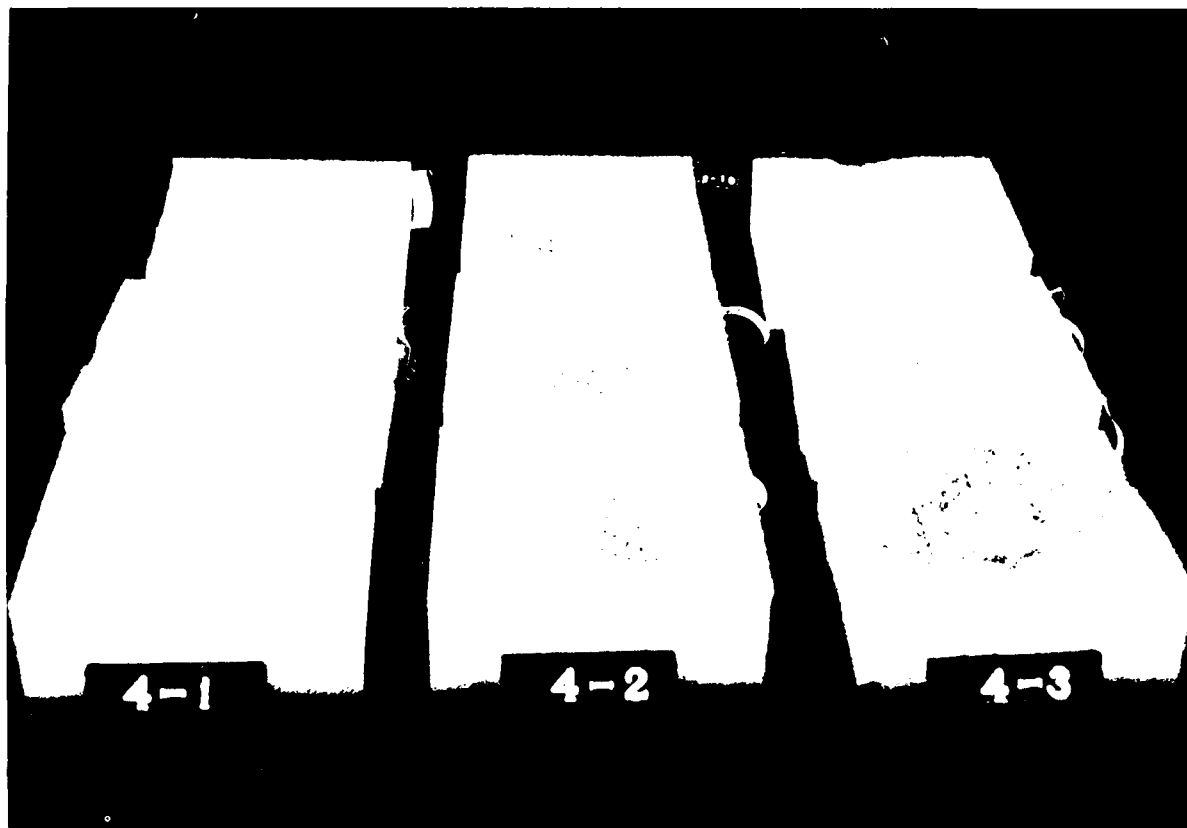
Figure A1-128. Perspective view of red foam specimens, subjected to sustained burning. Samples ignited by flame from top while in horizontal position, and from bottom while in vertical and horizontal positions, respectively.

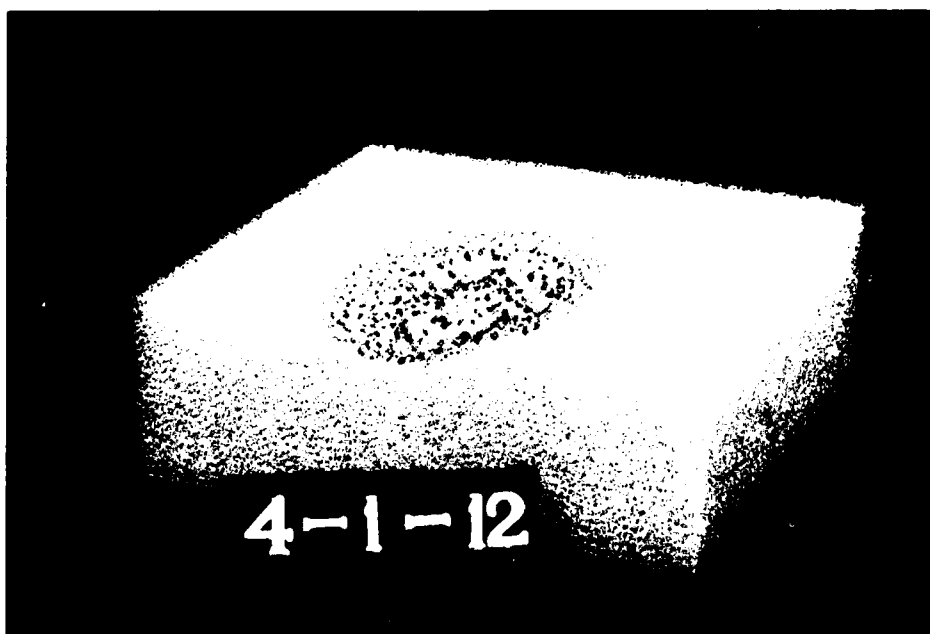
Figure A1-129. Sample 4-1-12, perspective view.

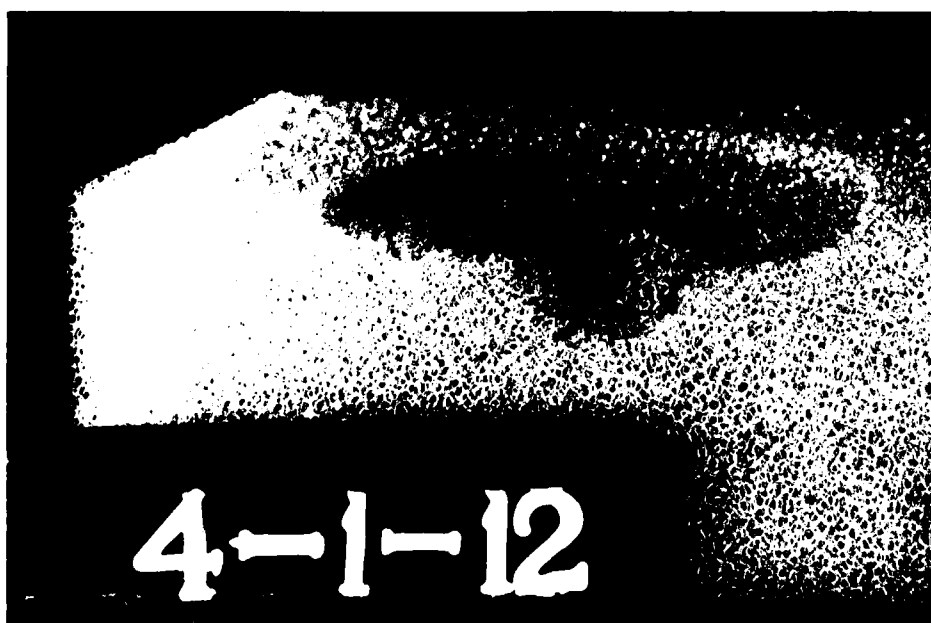
Figure A1-130. Sample 4-1-12, cross-sectional view.

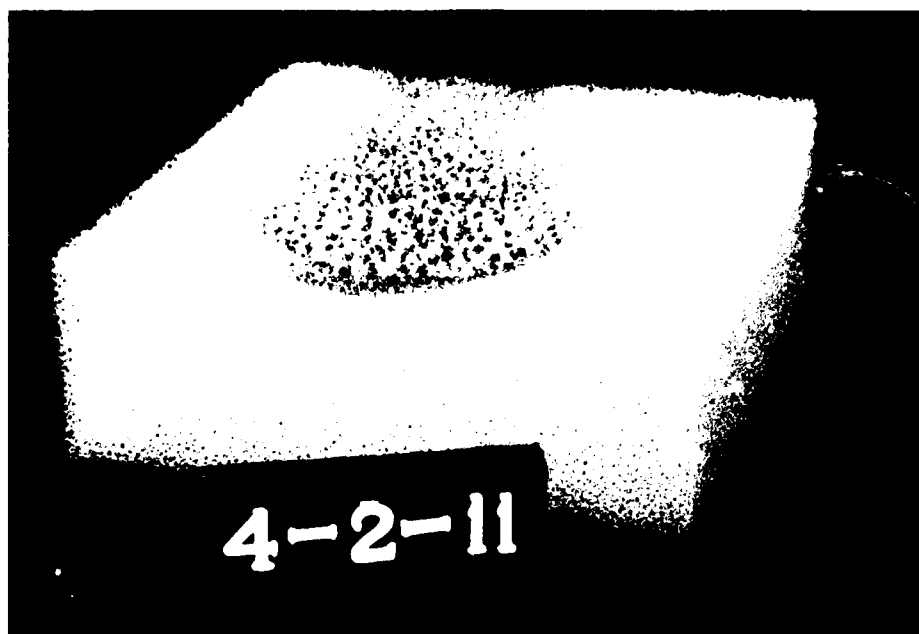
Figure A1-131. Sample 4-2-11, perspective view.

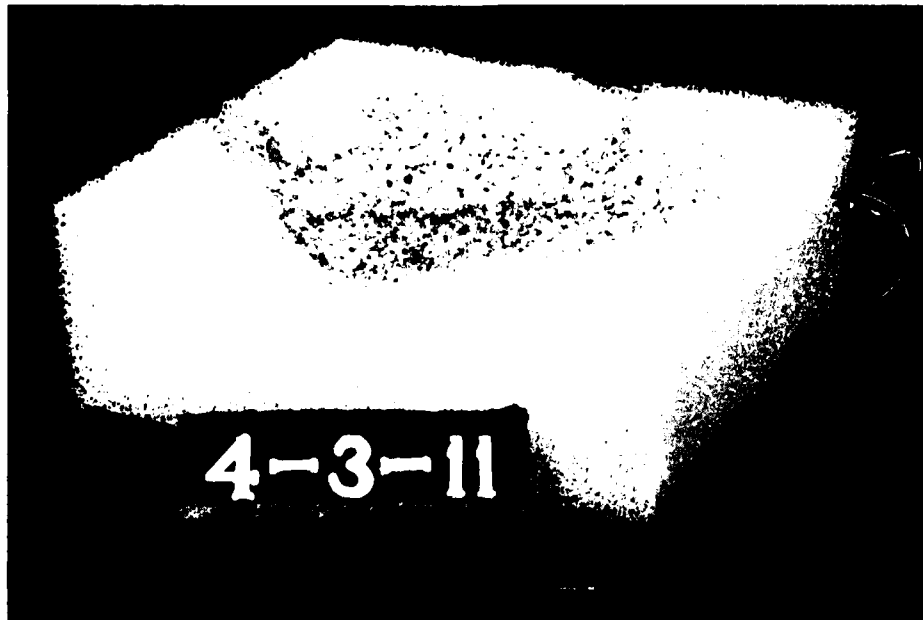
Figure A1-133. Sample 4-3-11, perspective view.

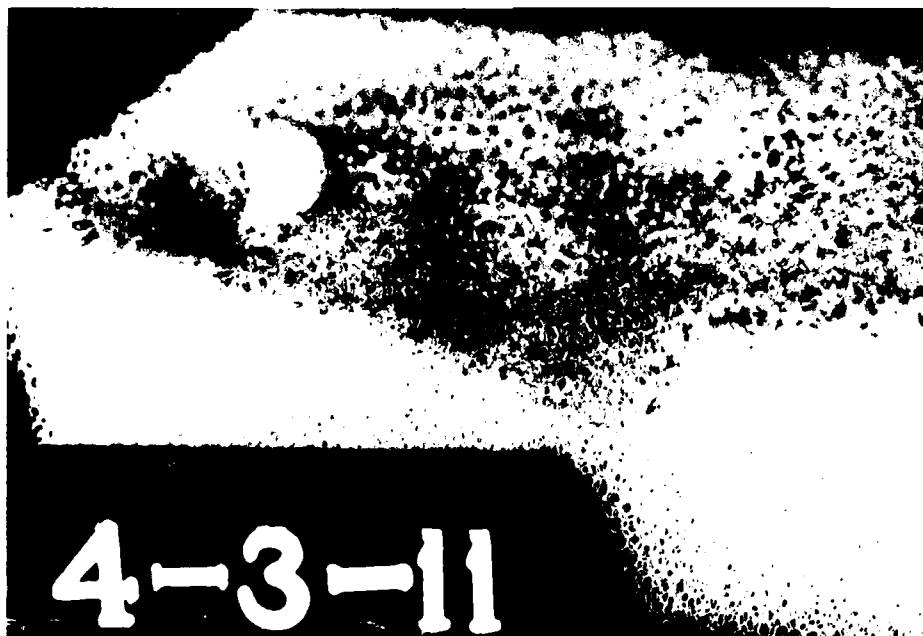
Figure A1-134. Sample 4-3-11, cross-sectional view.
